Quaternary, structural and engineering geology of the Aishihik River landslide, Cracker Creek area (NTS 115A/15), Yukon

Brideau, M.-A. et al., 2005. Quaternary, structural and engineering geology of the Aishihik River landslide, Cracker Creek area (NTS 115A/15), Yukon. *In: Yukon Exploration and Geology 2004*, D.S. Emond, L.L. Lewis and G.D. Bradshaw (eds.), Yukon Geological Survey, p. 83-94.

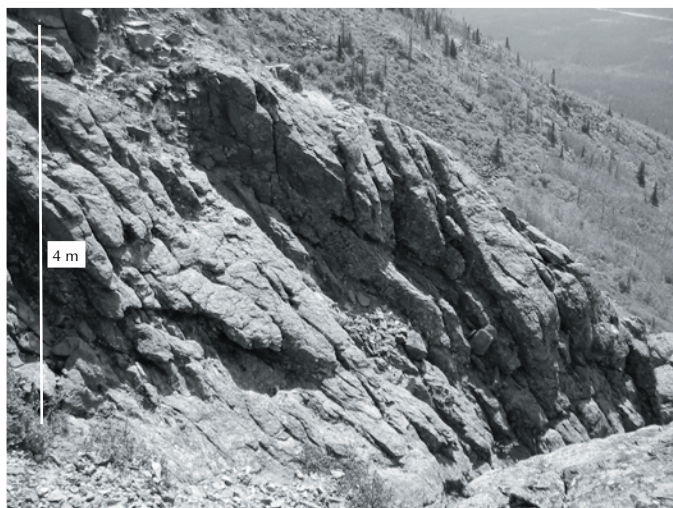
Figure 4. Dominant discontinuity set IV in the headscarp area of the Aishihik River landslide. Note the close spacing (60 to 200 mm) of the discontinuity set.

correlates with the lower rock mass quality in the headscarp area (Fig. 4).

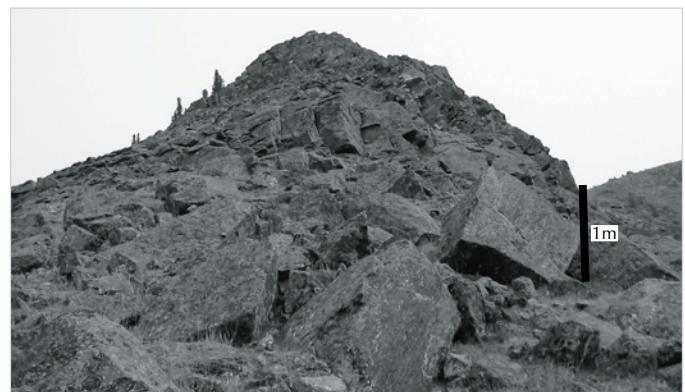
Figure 12. Blocky nature of the southwestern ridge. View looking northeast.

Observations made during fieldwork and a review of the air photographs provide a preliminary assessment of the current stability of the rock slope adjacent to the slope failure. Recent movement at the study site is indicated in the headscarp area by exposed soil and White River Ash in trenches, and disturbance to the vegetation (Huscroft et al., 2004). Both sidescarps are composed of a series of down-dropped blocks. The headscarp of the Aishihik River landslide extends beyond the western limit of failed material. Active block toppling and rock fall zones are present on the western sidescarp.
